Illinois Commerce Commission  
Assessment of Central Illinois Light Company's  
Reliability Report for the 2000 Period

Pursuant to 83 Ill. Adm. Code 411.140

**December 12, 2001**

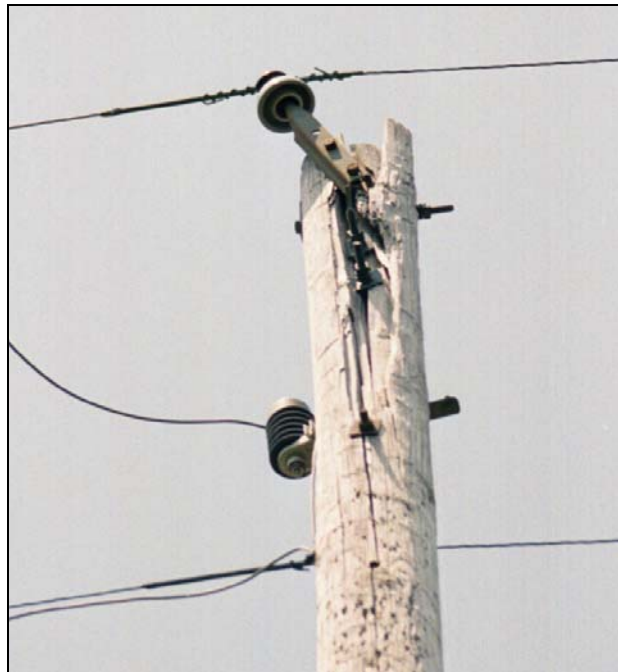
Circuit 00-036-002 is a 13.2 kV circuit serving portions of the town of Eureka (east of Peoria) and a rural area mostly east and south of Eureka. During the field inspection of this circuit in July, 2001, Staff noted that additional lightning arresters and grounds have been added at several locations. Trees were close to the primary at one location, but the tree trimming on this circuit was generally in good condition. Some split pole tops (see Figure 1) and split crossarms were observed as noted in the summary for this circuit, Attachment A, but the inspection did not reveal an obvious reason for the circuit's poor performance in 2000.

**Figure 1**  
**Split Pole Top**  
**Eureka Circuit 00-036-002**

Sixth, CILCO should consider improving lightning protection on Eureka circuit 00-036-002.

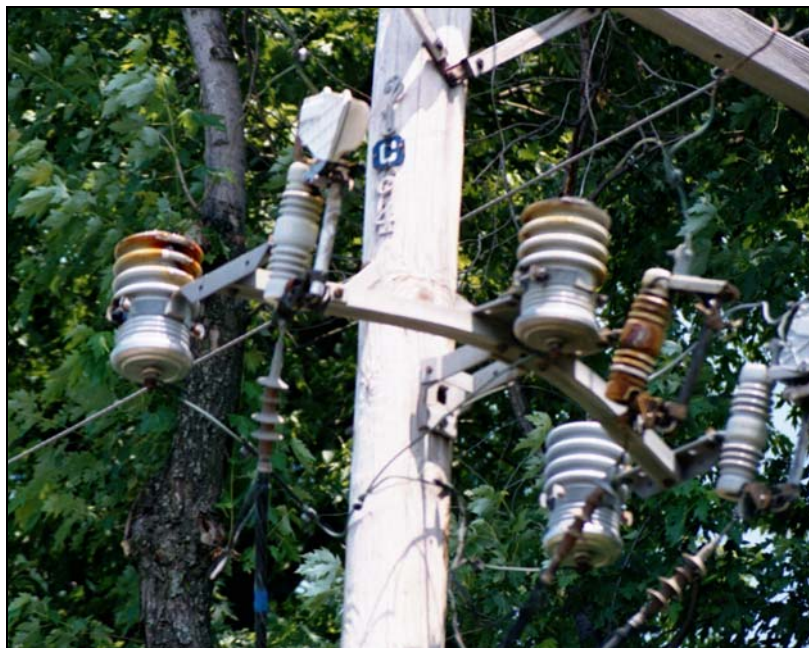
Circuit 00-181-001 is a 13.2 kV circuit serving the town of Groveland (south of Peoria) and rural areas surrounding Groveland. A significant portion of this circuit is underground. During the field inspection of this circuit in July, 2001, Staff noted that trees were into the primary in a few locations, but the overhead portions of this circuit were generally trimmed and in good shape. At one location there was evidence of electrical flashover of equipment on a primary riser pole (see Figure 2). Lightning was listed as a reason for this circuit being classified as a worst performing circuit in 2000, and this is evidence of that problem. No improvement in lightning protection was mentioned in CILCO's plan to improve the reliability of this circuit, nor were new lightning arrester installations noted during Staff's field inspection of this circuit, however. The Commission urges CILCO to consider improving lightning protection on this circuit. See Attachment B for a summary of problems noted during the field inspection of this circuit.

**Figure 2**  
**Flashed Potheads, Cutouts, & Arresters**  
**Groveland Circuit 00-181-001**

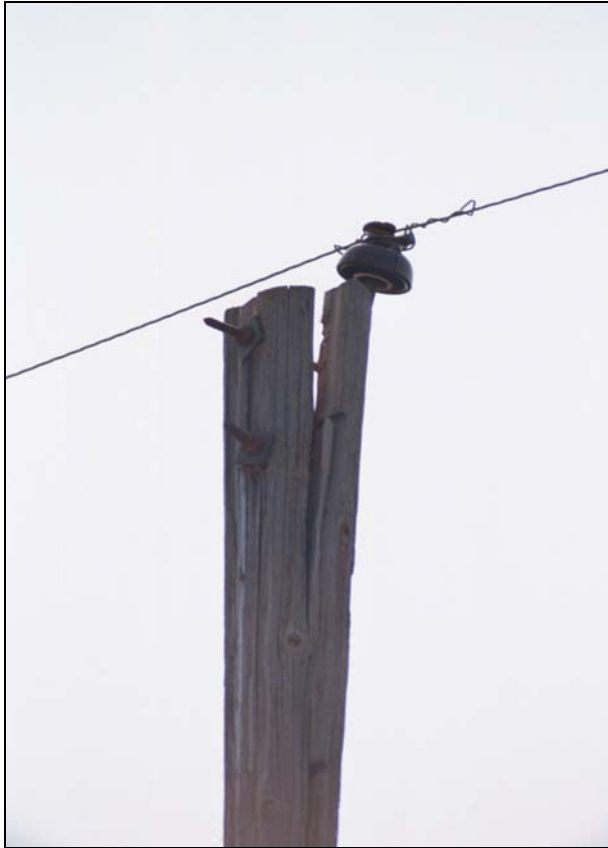
Circuit 00-182-002 is a 12.5 kV circuit fed from CILCO's Stark substation and serving a rural area mostly south of Wyoming (northwest of Peoria). During the field inspection of this circuit in August, 2001, Staff observed that lightning arresters have been added at several locations throughout the circuit, even though that was not mentioned in CILCO's plan to improve the reliability of this circuit. Several tree problems and numerous structural problems were observed on this circuit, as noted in the summary for this circuit, Attachment C. Some of the more common structural problems included split pole tops, shell rotted poles, woodpecker holes in poles, and lightning damaged poles (see Figures 3 and 4). These problems and the large rural exposure are likely reasons for the poor performance of this circuit in 2000 and potential poor performance in the future. The Commission urges CILCO to address the tree and structural problems on this circuit in an effort to prevent it from repeating as a worst performing circuit.

**Figure 3**  
**Split Pole Top**  
**Circuit 00-182-002**

Seventh, CILCO should address the tree and structural problems on circuit 00-182-002 south of Wyoming.

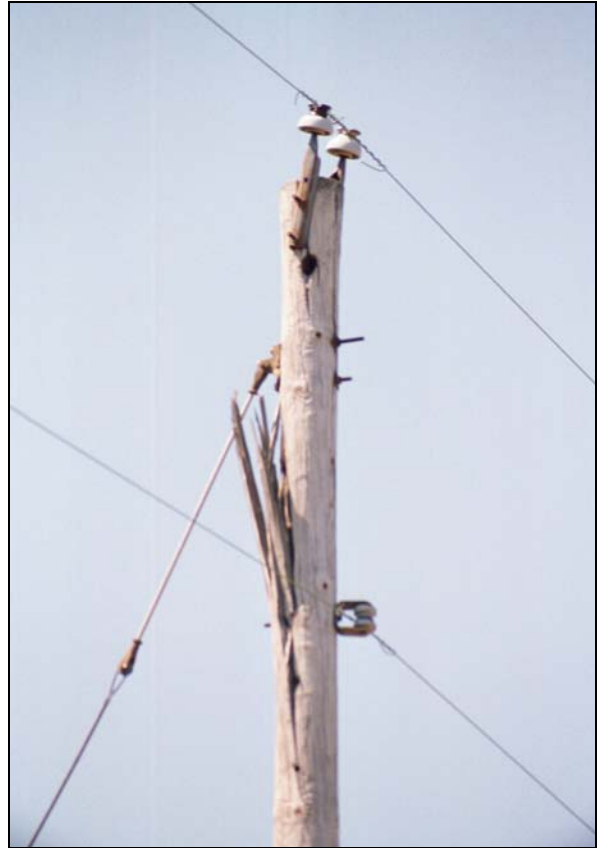
**Figure 4**  
**Woodpecker Hole & Lightning Damage**  
**Circuit 00-182-002**

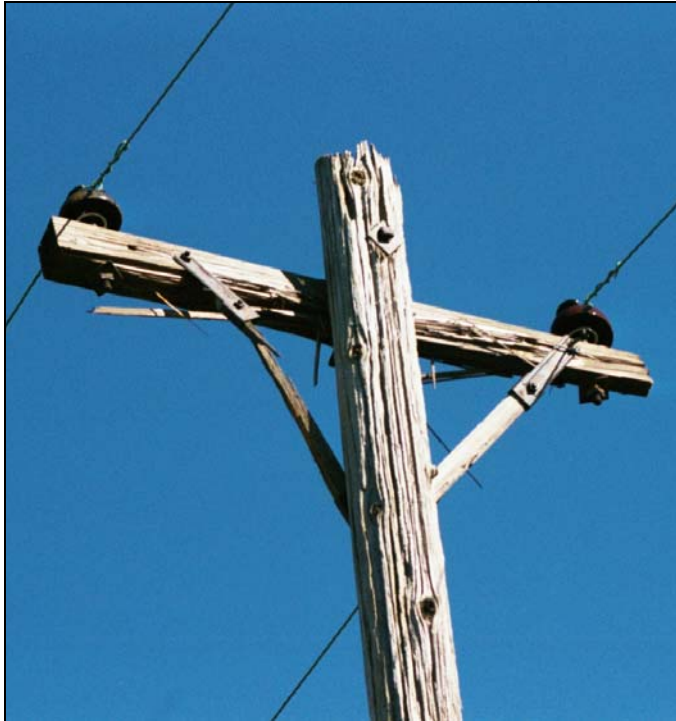
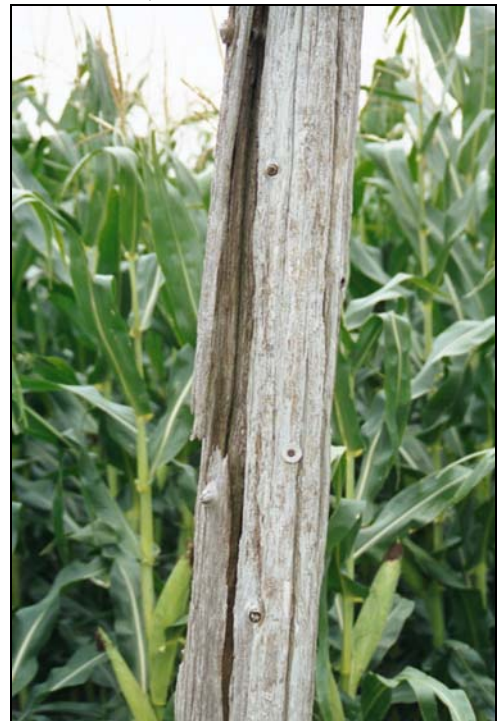
Circuit 00-328-124 is a 12.5 kV circuit serving the towns of Washburn, LaRose, Low Point, and Cazenovia (all northeast of Peoria) and a large rural area surrounding those communities. While not one of the 1% worst performing circuits required to be identified in the annual reliability report, this circuit was CILCO's "next-worst SAIFI circuit" in 2000. The field inspection of this circuit by Staff in July, 2001, revealed an extensive list of potential reliability and safety problems, as noted in the summary for this circuit, Attachment D. Examples of the widespread structural problems noted include 29 split crossarms, 37 other locations with pins fallen through the arms (indicating crossarm rot), and 12 locations with damaged crossarm braces. 36 badly shell rotted poles, 30 split pole tops, and 21 locations with apparent lightning damage to poles were noted. 14 poles with woodpecker damage were noted. Sample photographs of some of these problems are provided in Figures 5 through 13.

**Figure 5**  
**Shell Rotted Pole w/ Splintered Crossarm & Brace (Probable Lightning Damage)**  
**Both Photos Are of Same Pole, Treated in 1954 & 1988, Circuit 00-328-124**

Eighth, CILCO should perform an inspection of Washburn circuit 00-328-124 and take prompt, appropriate action to fix the structural or other problems that may have an adverse effect on reliability or public safety.

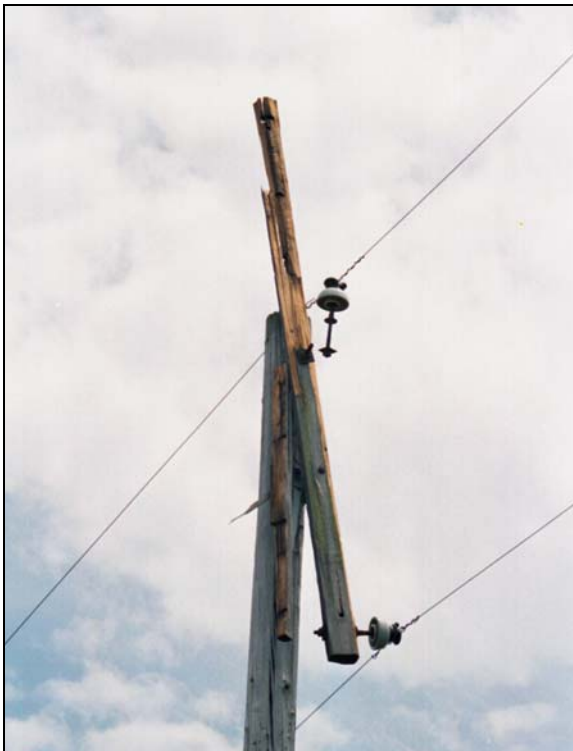
**Figure 7**  
**Lightning Damaged Structure**  
**Circuit 00-328-124**

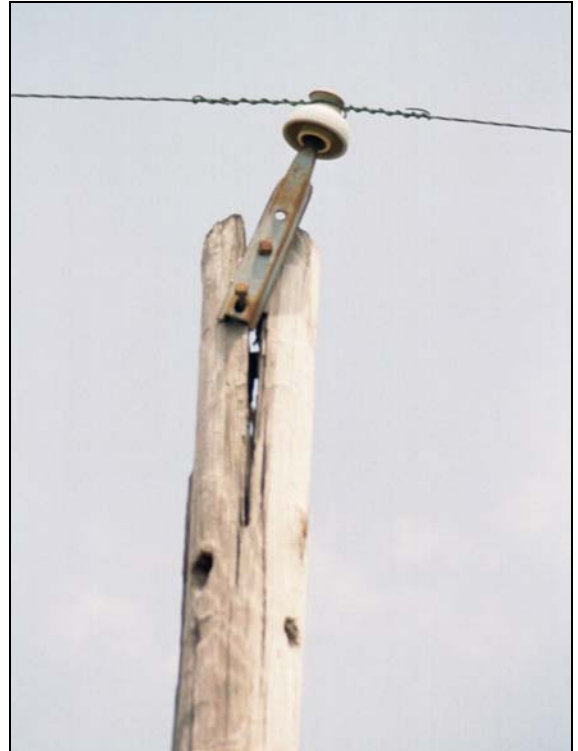
**Figure 8**  
**Split Pole Top**  
**Circuit 00-328-124**

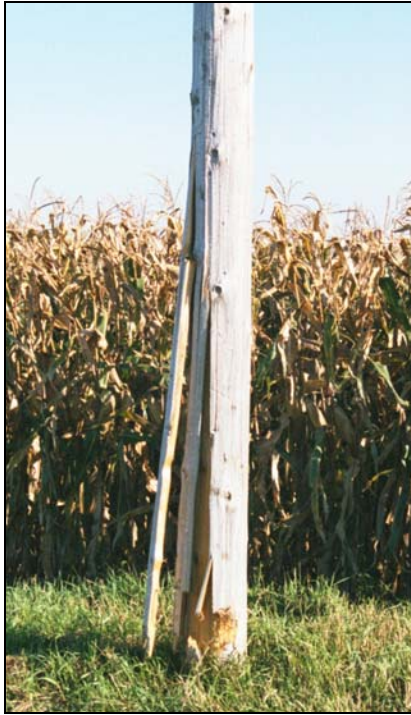
**Figure 9**  
**Split, Shell Rotted Pole**  
**Circuit 00-328-124**

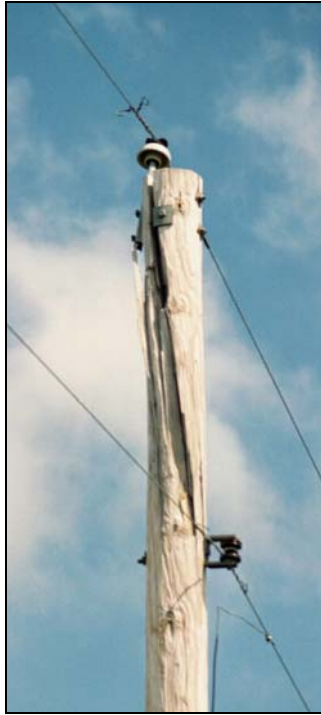
**Figure 10**  
**Lightning Damaged Pole**  
**Circuit 00-328-124**

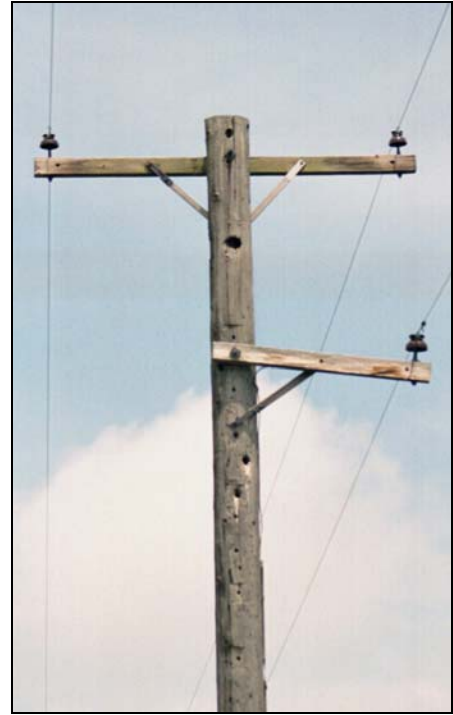
**Figure 11**  
**Woodpecker Holes**  
**Circuit 00-328-124**

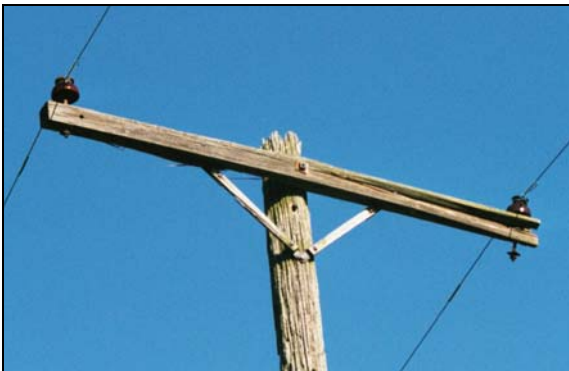
**Figure 12**  
**Split Crossarm & Pin Through Arm**  
**Circuit 00-328-124**

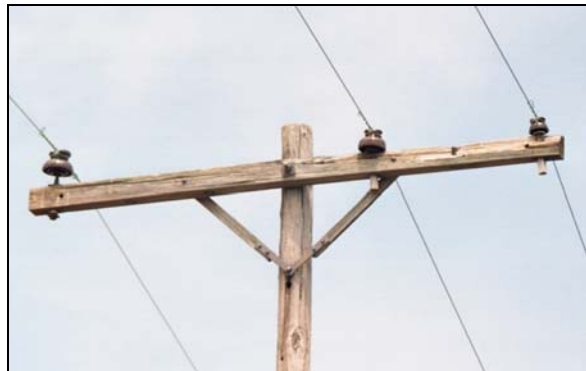
**Figure 13**  
**Wood Pins Through Rotted Crossarm**  
**Circuit 00-328-124**
